# Archangelos Michael Church

This is a project of the Technical Committee on Cultural Heritage

## PROJECT OVERVIEW

*Type of intervention:* **Conservation Works**

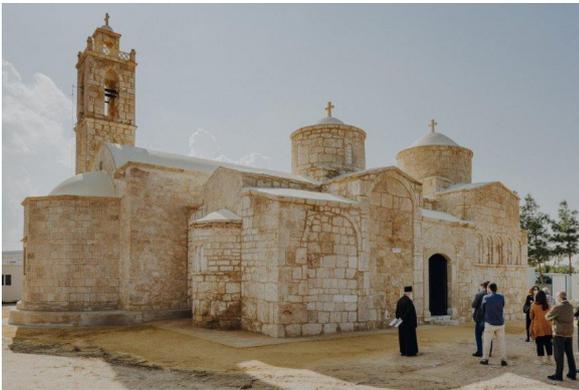
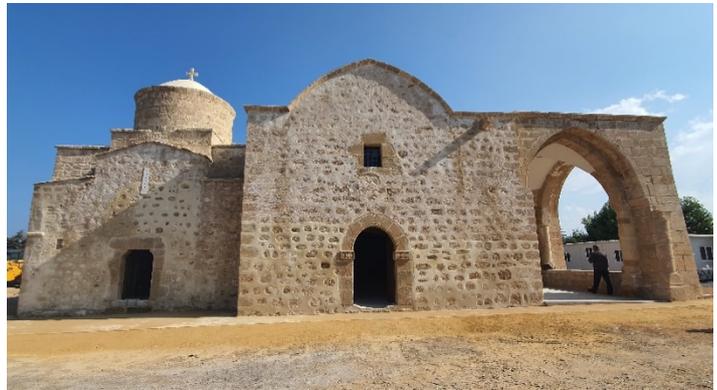
The church is the result of several construction phases dating from the Byzantine period to the middle of the 20th century. It is a twin church; a composition of two churches attached to each other with an additional open portico to the south side.

The church is of the cross-in-square type with four piers on which a cylindrical dome is resting. The central and side aisles are roofed by cylindrical vaults. To the east, there is a projecting semicircular apse. Interesting features of the apse are the triple-light window and the double sawtooth brick cornice which are common characteristics of Byzantine architecture but are relatively scarce in Cyprus. The north facade is formed by three large blind arches which is also a typical characteristic of Byzantine architecture.

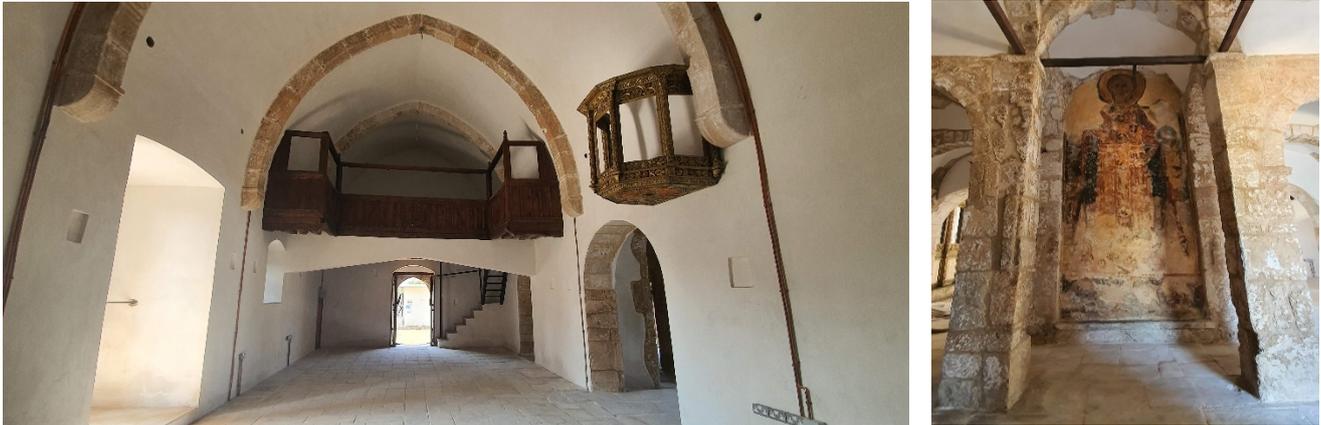
The church was extended to the west in the late Byzantine period, and a narthex was created. The narthex is of the cross-in-square compressed type and is also covered by a cylindrical dome in the center and cylindrical vaults to the north and south sides. The dome of the narthex does not have any windows. On the external side of the north wall there is a series of five recessed flat blind arches over a horizontal string-course. The external flat blind arch is a characteristic feature of Byzantine architecture which is met only in few churches in Cyprus.
